Manhole Inspection Summary

Manhole # S21GG_011MH

Insp Date: **6/14/07 11:02 AM**

Location Address: **1616 MCKEAN AVE**

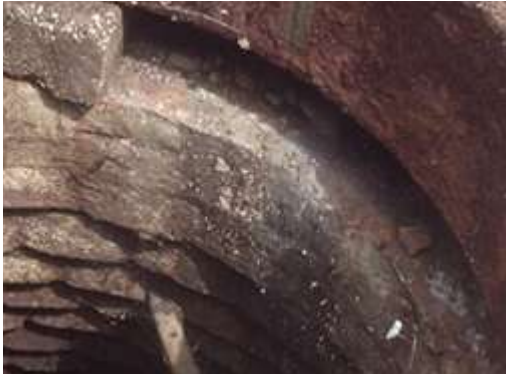
Defect 3

Comments **chimney material looks to be cinder.**

Condition: ☐ Sound ☐ Cracked ☐ Root Intrusion ☐ Loose Brick ☒ **Deteriorated**

CHIMNEY DETERIORATION

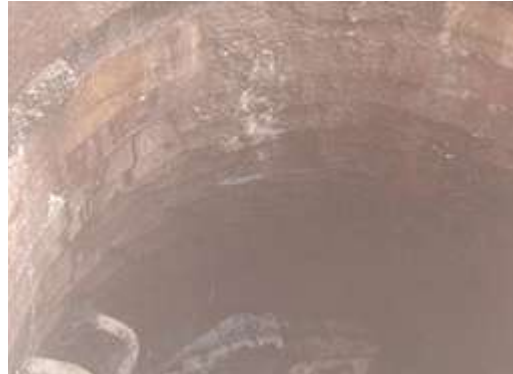
Defect 2

Infiltration: ☐ None ☐ Joint ☐ Cracks ☐ Mortar ☐ Roots ☒ **Wall**

INFILTRATION OF CHIMNEY

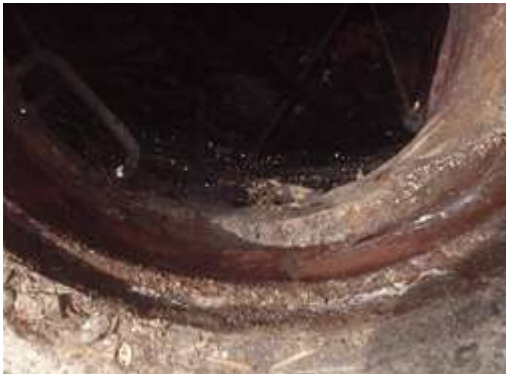
Defect 1

Frame Offset: **1** (in.) Condition: ☒ Sound ☐ Cracked ☐ Leaks

FRAME OFFSET

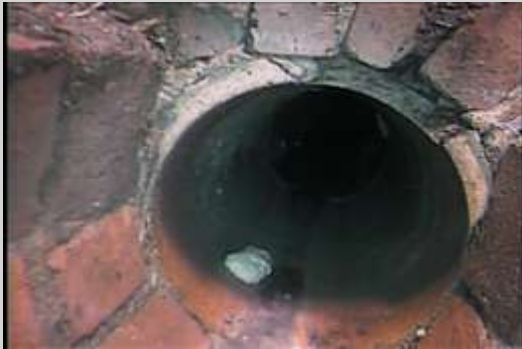
12 O'Clock Outflow

8 in. Circular Gravity Sewer
Pipe Out @ 12 O'Clock

Pipe Height: **8.4** (in.) Rod and Bar (Angled)
Pipe Material: **Clay** ☐ Pipe Lined
Invert Depth: **7.24** (ft.) Flow Characteristics: **None**
Deposits: ☒ None ☐ Mud ☐ Sludge ☐ **Debris** ☐ Grease
Silt Depth: (in.) Deposits Extent:
Infiltration: **None** Pipe Seal Cond: **Broken**

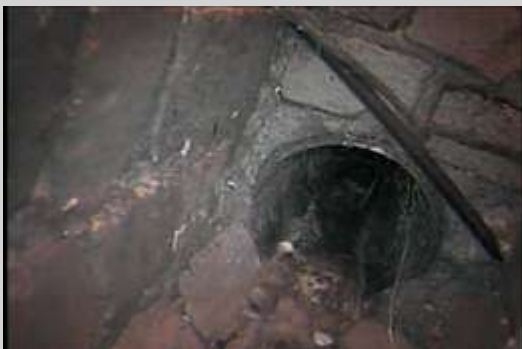
9 O'Clock Inflow

6 in. Circular Gravity Sewer
Pipe In @ 9 O'Clock

Pipe Height: **6** (in.) Rod and Bar (Angled)
Pipe Material: **Clay** ☐ Pipe Lined
Invert Depth: **7.23** (ft.) Flow Characteristics: **None**
Deposits: ☐ None ☐ Mud ☐ Sludge ☒ **Debris** ☐ Grease
Silt Depth: **2** (in.) Deposits Extent: **Light**
Infiltration: **None** Pipe Seal Cond: **Sound**
